ALASKA HIGHWAY CORRIDOR LANDSLIDE HAZARD STUDY

Crystal Huscroft, Panya Lipovsky and Jeffrey Bond
Yukon Geological Survey

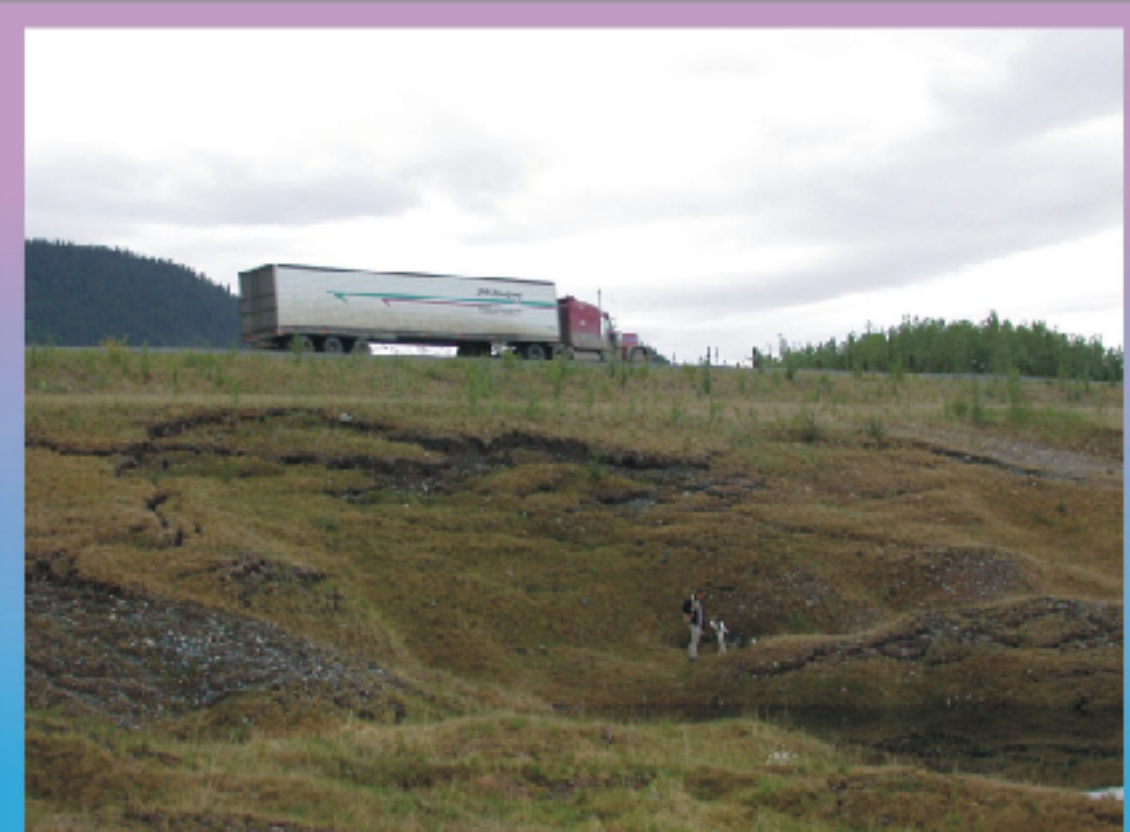
2 Beaver Creek
Permafrost subsidence in abandoned gravel pit adjacent to Alaska Highway. Subsidence is related to thermokarsting caused by gravel and vegetation removal adjacent to highway.

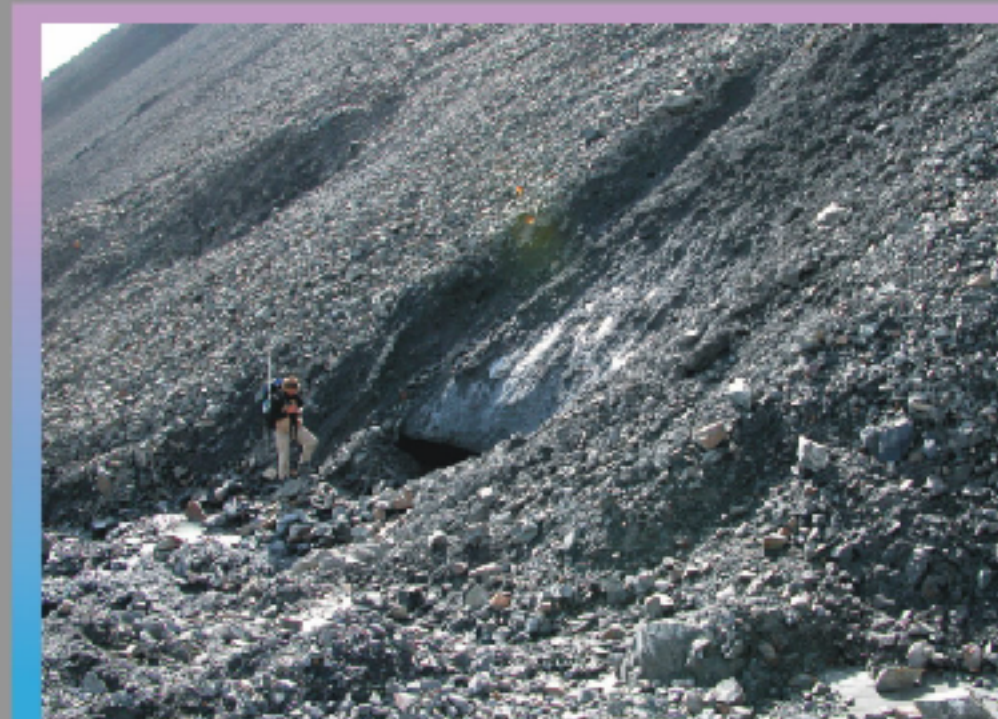
5 Mount Archibald Rock Glacier
Loose-rich colluvium in alpine basins provides a major source of material for debris flows that transport debris down to the valley bottom.

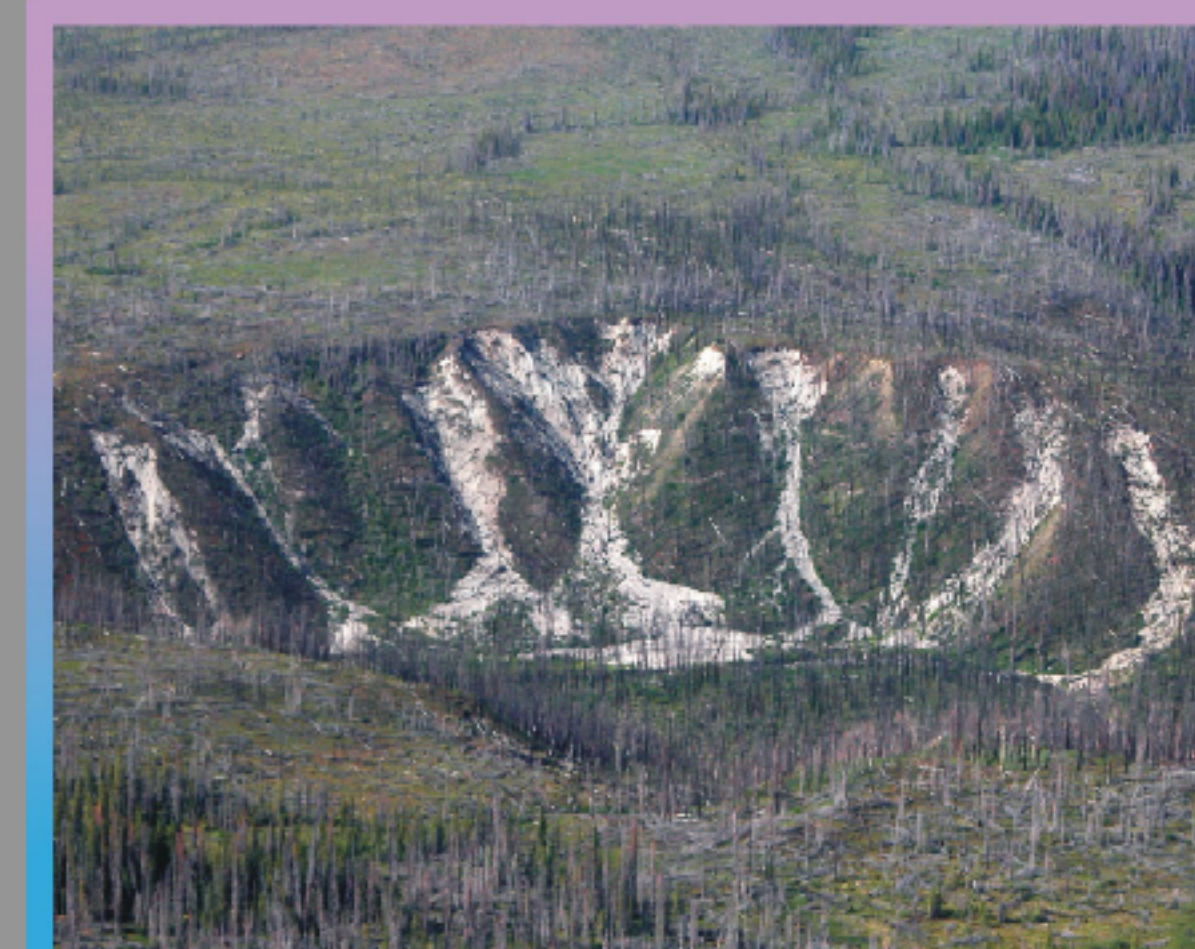
6 Marshall Creek
A collection of post-fire debris flows in Marshall Creek basin. Forest fire related flows since 1998 has caused forty-one failures in the 37 km burn.

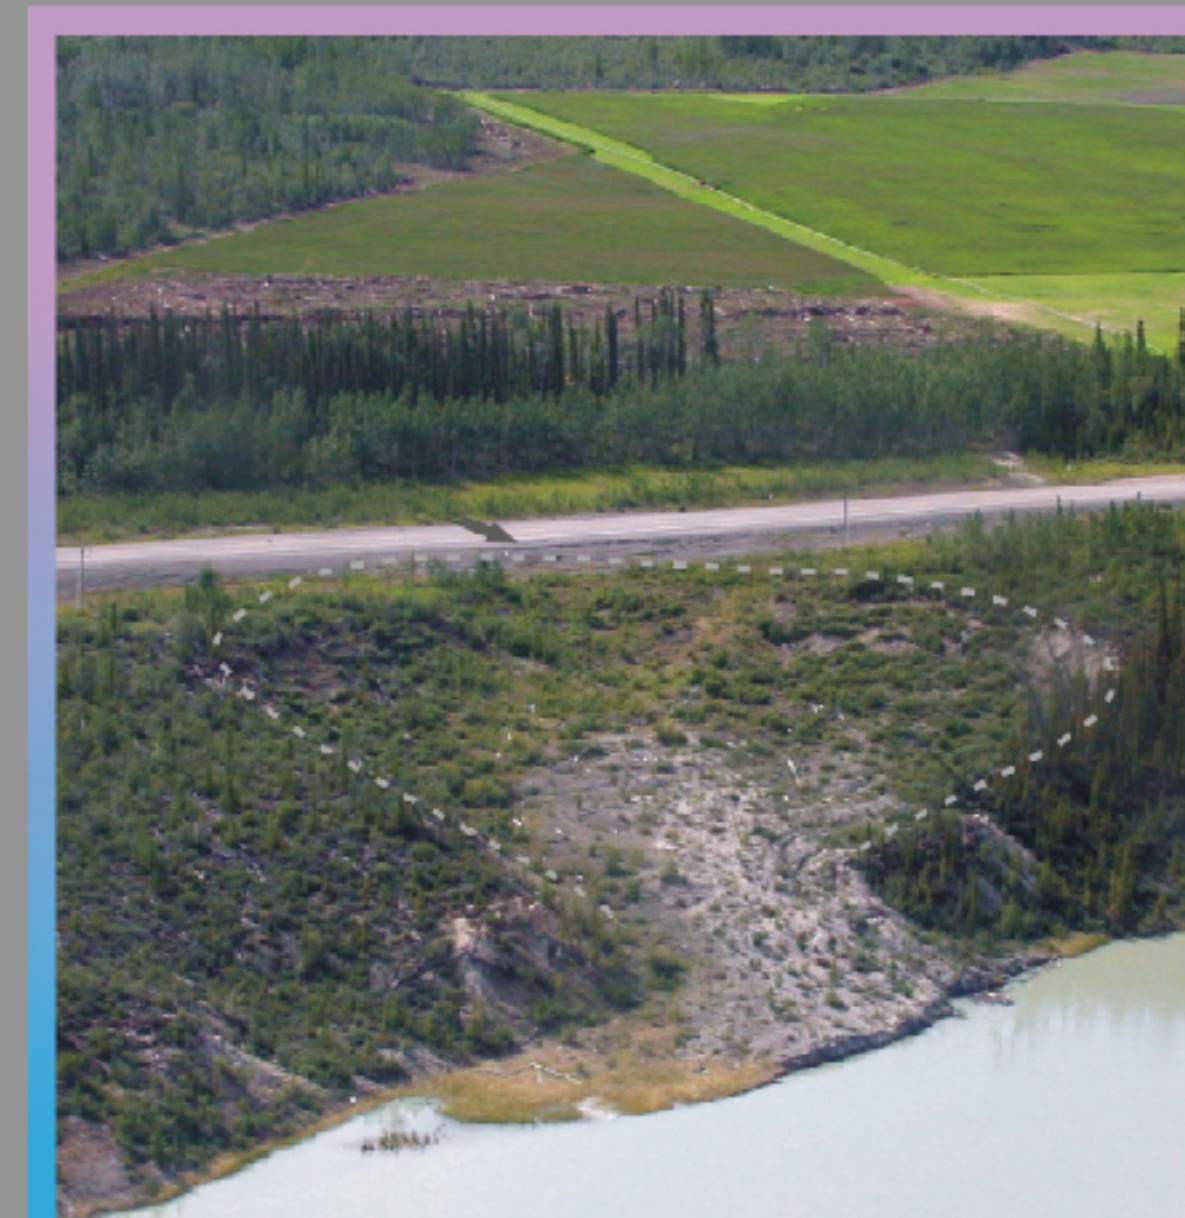
7 Takhini River
Abandoned retrogressive ground ice slump in the Takhini River Valley adjacent to Alaska Highway. Note new cracks in highway fill as heeswall stabilizes (arrow). Permafrost thaw related to river undercutting, forest fire, proximity to highway, and forest cover removal in adjacent agricultural fields may contribute to permafrost degradation and the failure. Dashed line highlights remnant roadcarp.

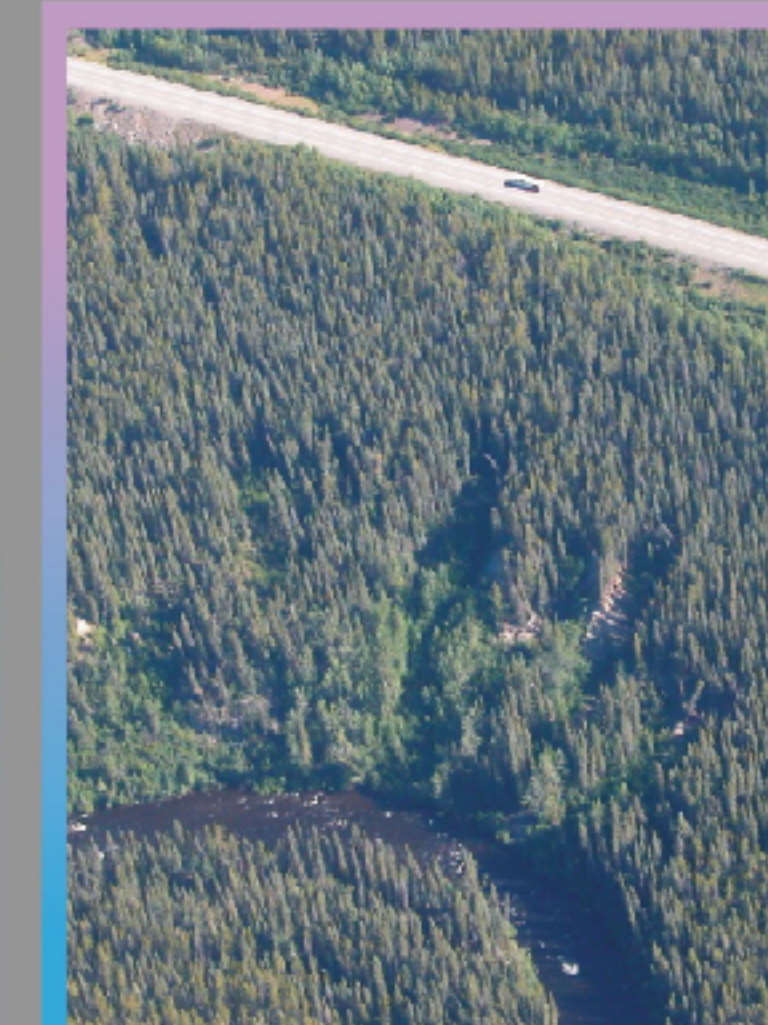
10 Morley River
Debris flows in basal fill along the Morley River. Inset photo taken in debris flow channel. Person at top of channel for scale.

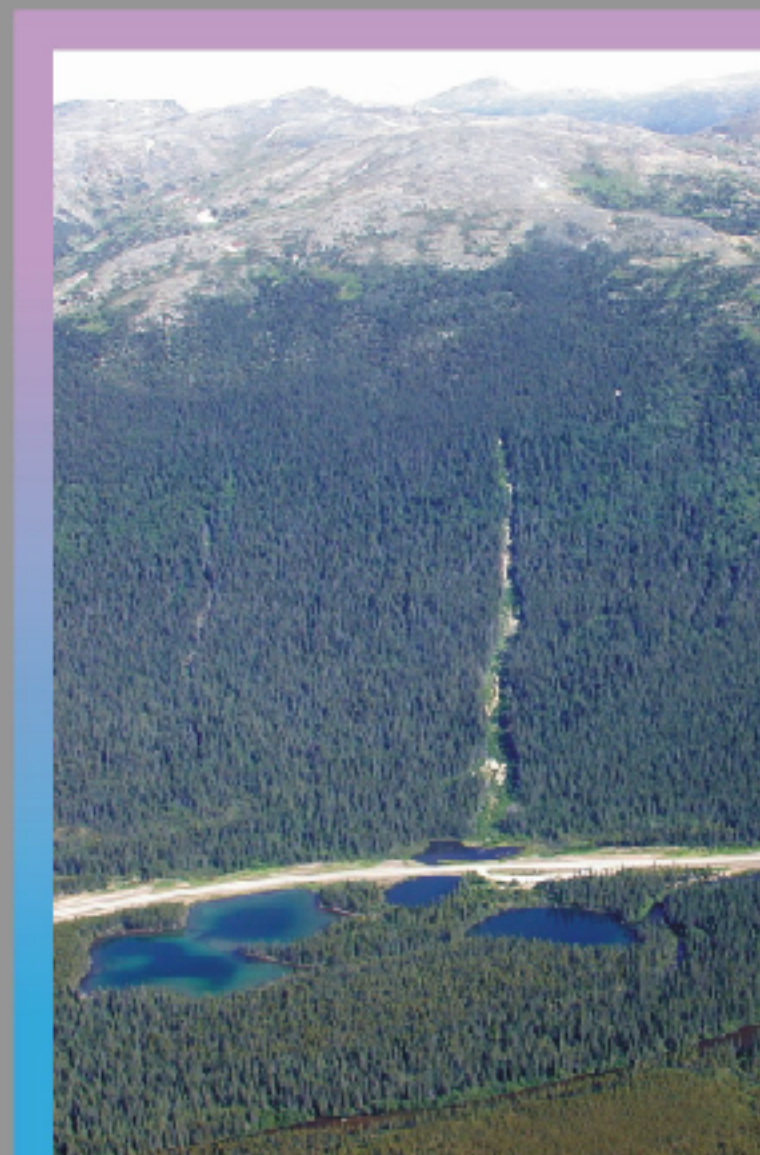
11 Rancheria
Debris flow on south-facing slope near Rancheria, induced by intense rainstorm in 1958. Alaska Highway in foreground.

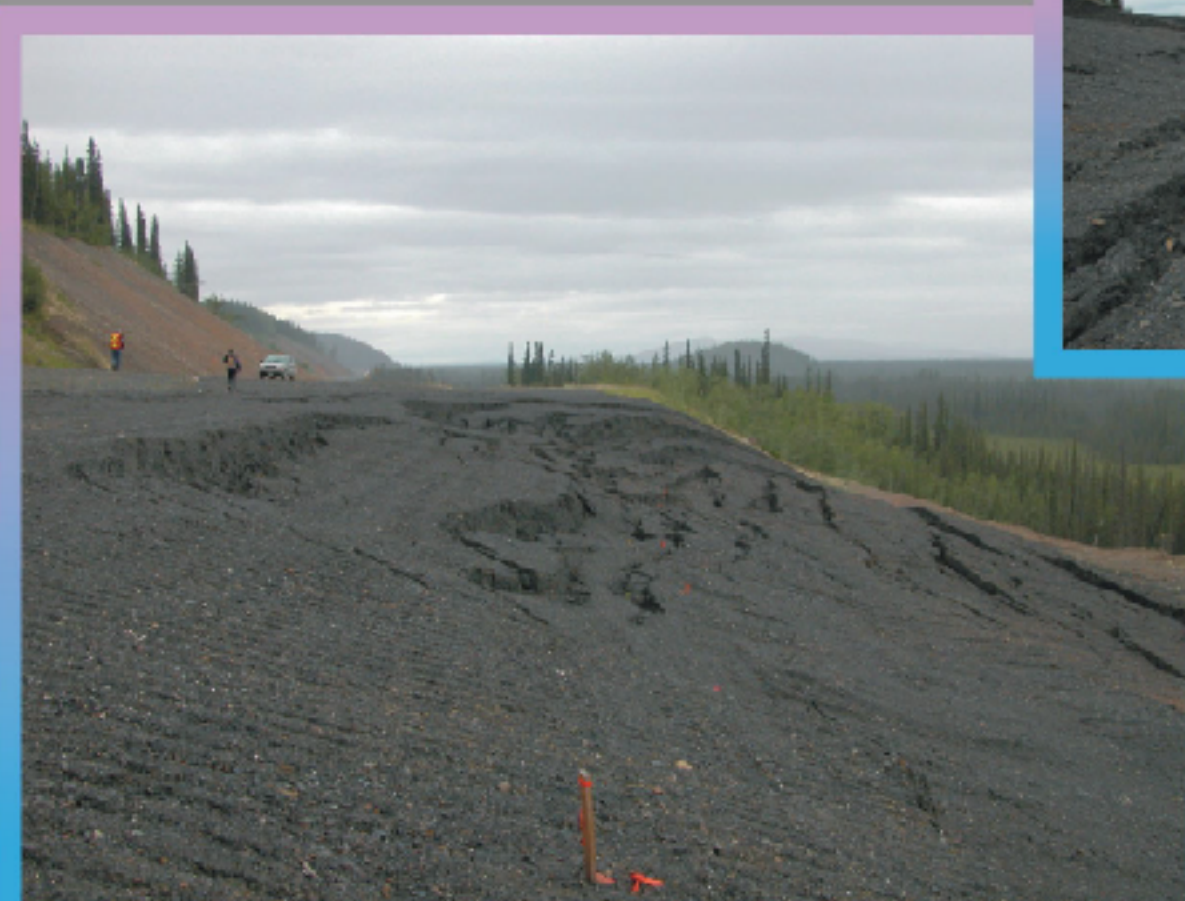
1 Beaver Creek
Embankment failure along new highway approach caused by flow of a massive segregated ice lens. This failure formed by groundwater discharge at the base of a bedrock valley wall into permeable glacially derived sands, gravel, and silt. Inset shows magnitude of ground movements.

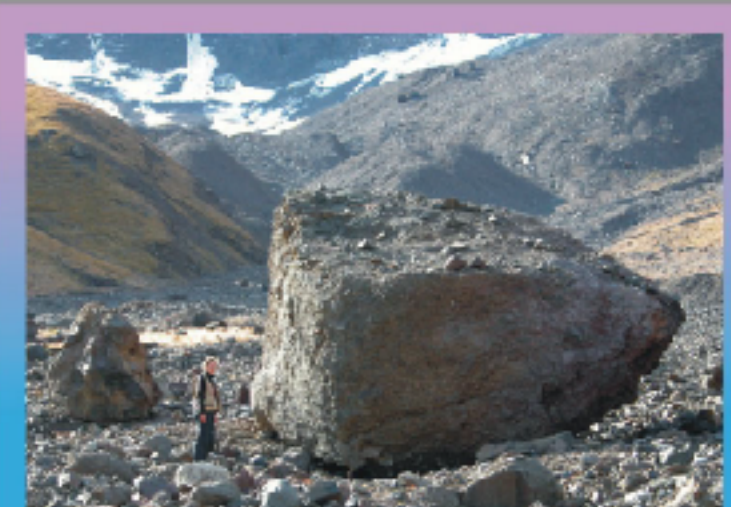
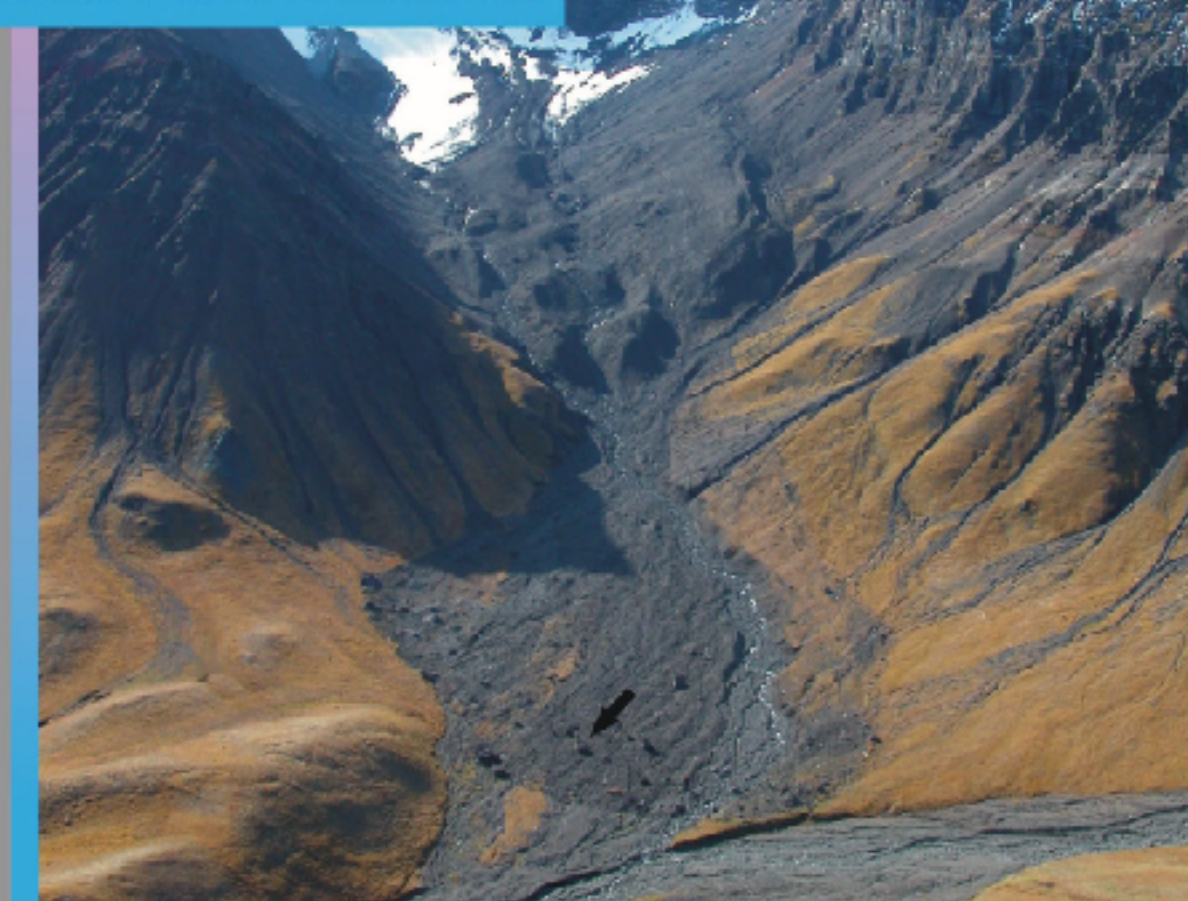
3 Nines Creek Rock Avalanche
Rock and snow avalanche in the headwaters of Nines Creek associated with catastrophic glacial deaestressing. The source of the avalanche is above the steep, right-hand rock faces. Inset shows large boulder that travelled over a kilometre from the initial rockfall face.

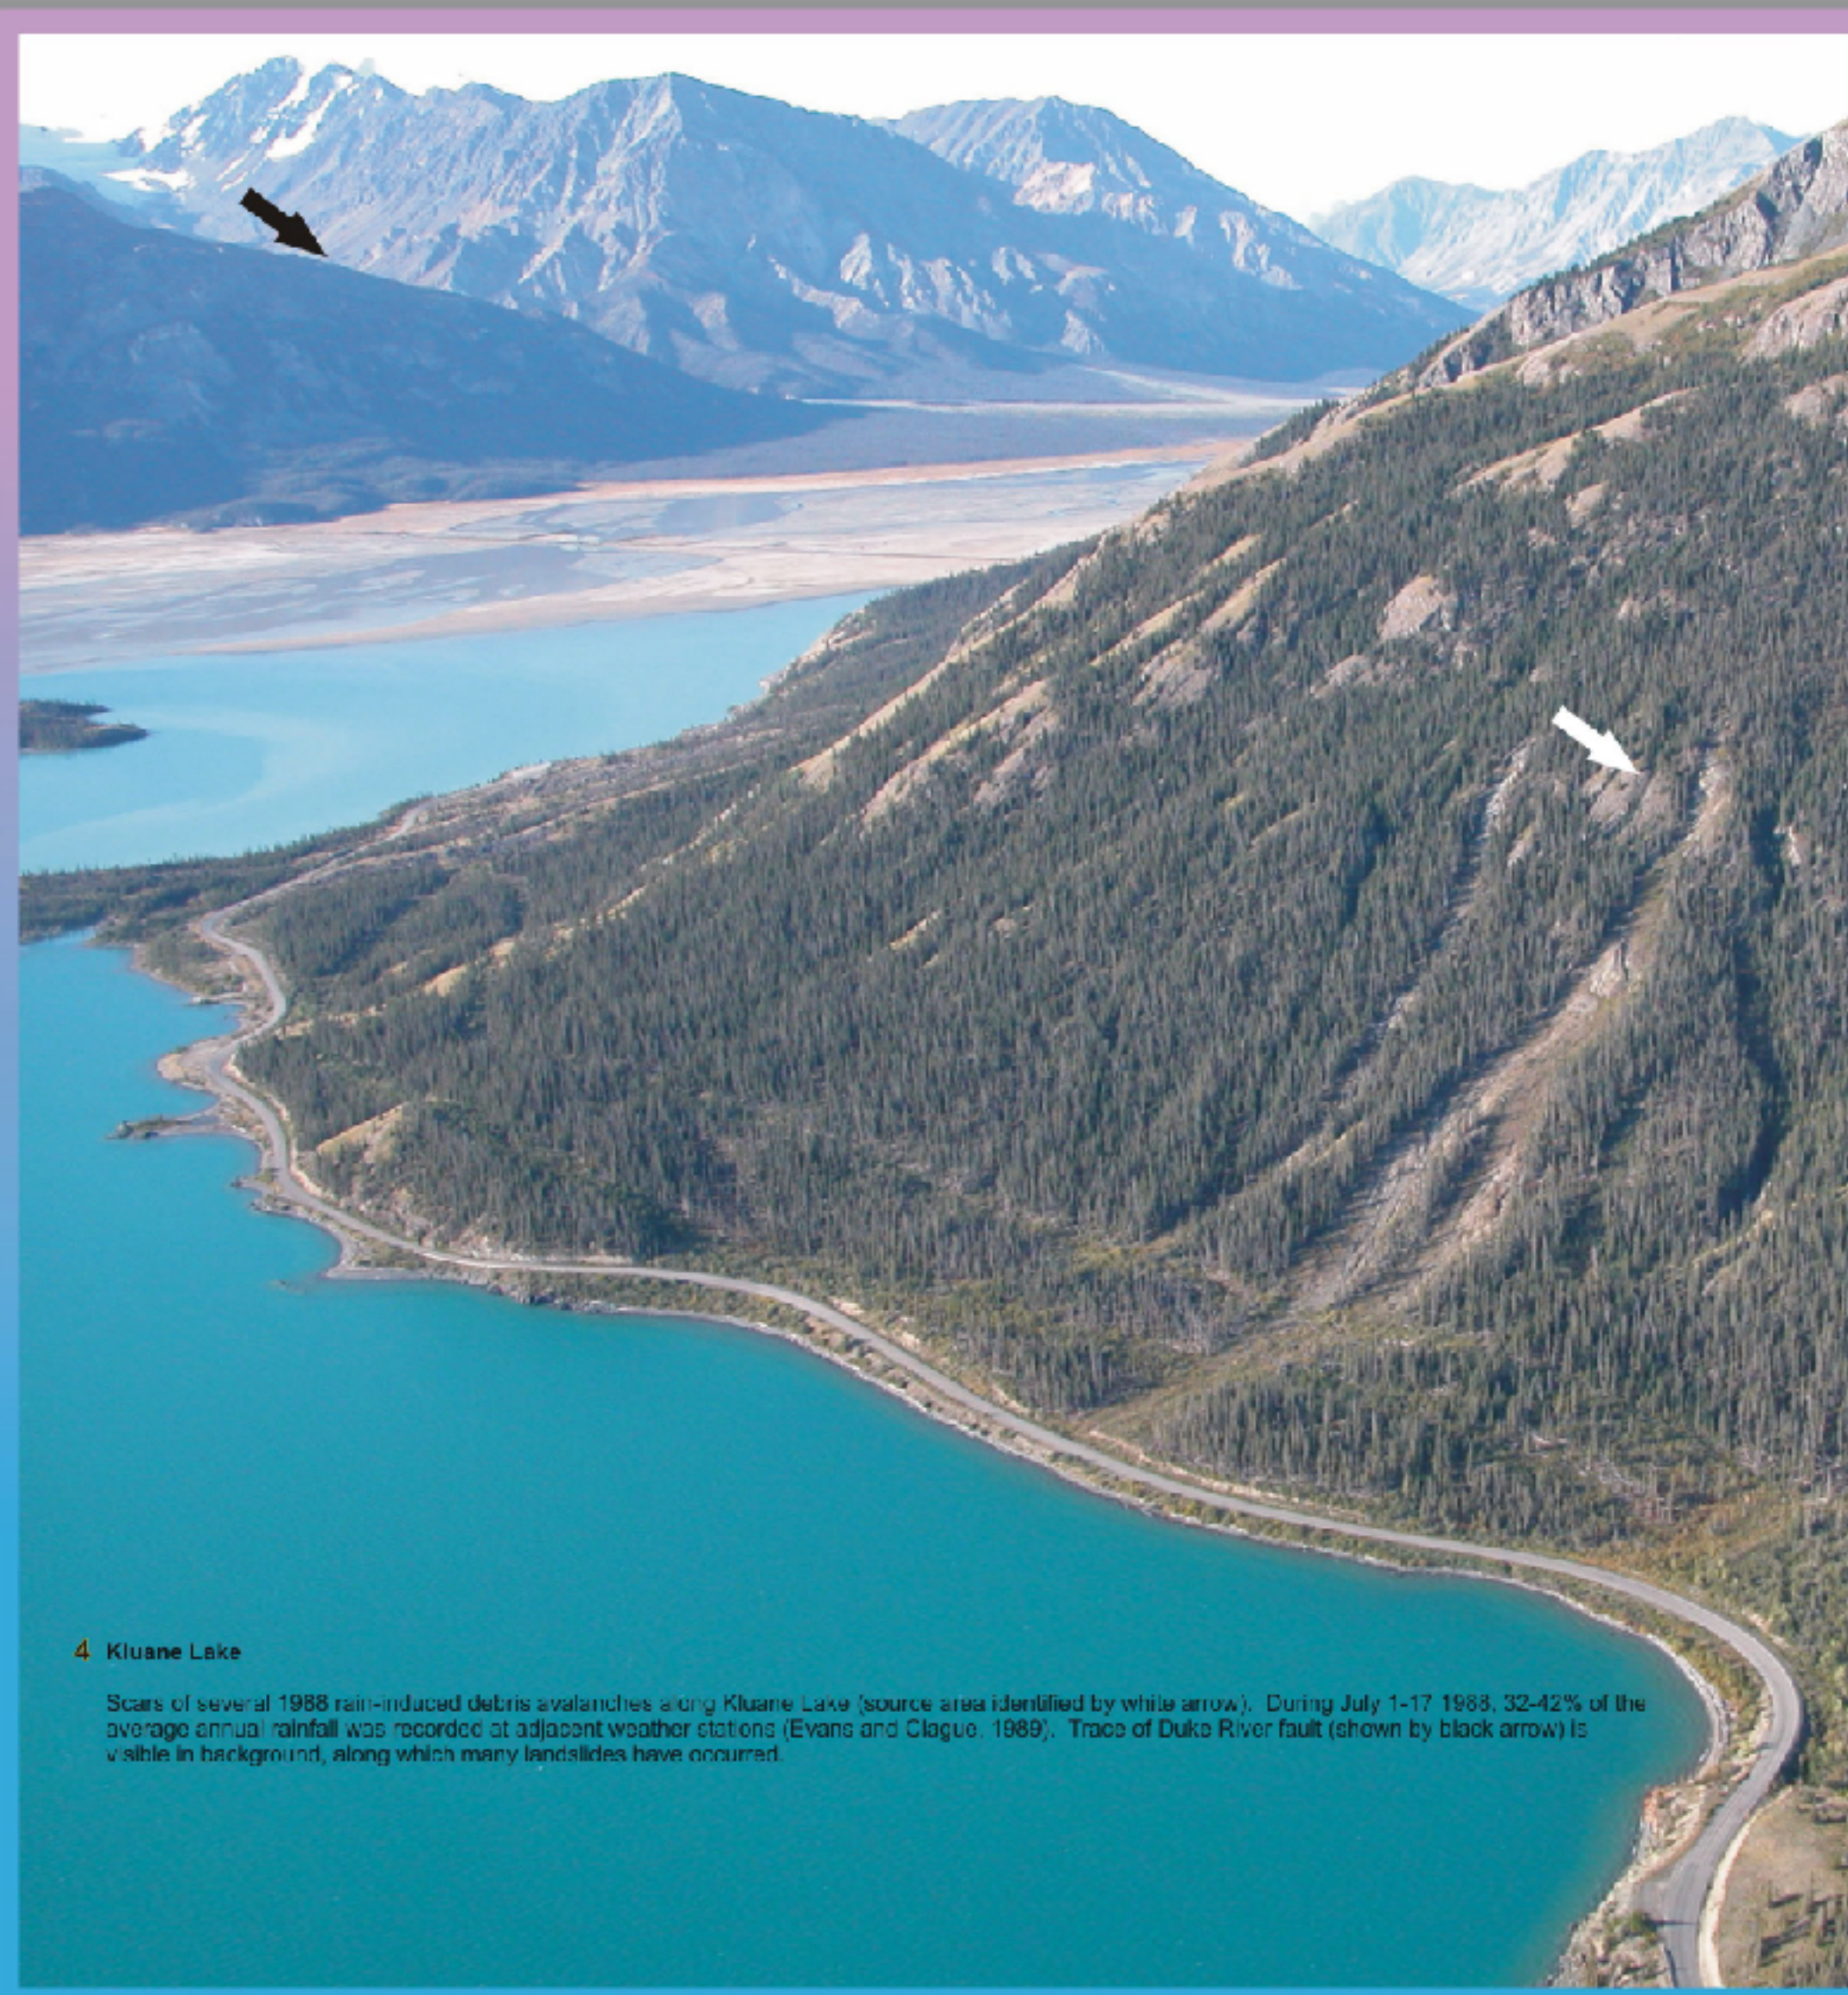
4 Klusne Lake
Scars of several 1998 rain-induced debris avalanches along Klusne Lake (source area identified by white arrow). During July 1-17 1998, 32-42% of the average annual rainfall was recorded at adjacent weather stations (Evans and Clague, 1999). Traces of Duke River fault (shown by black arrow) is visible in background, along which many landslides have occurred.

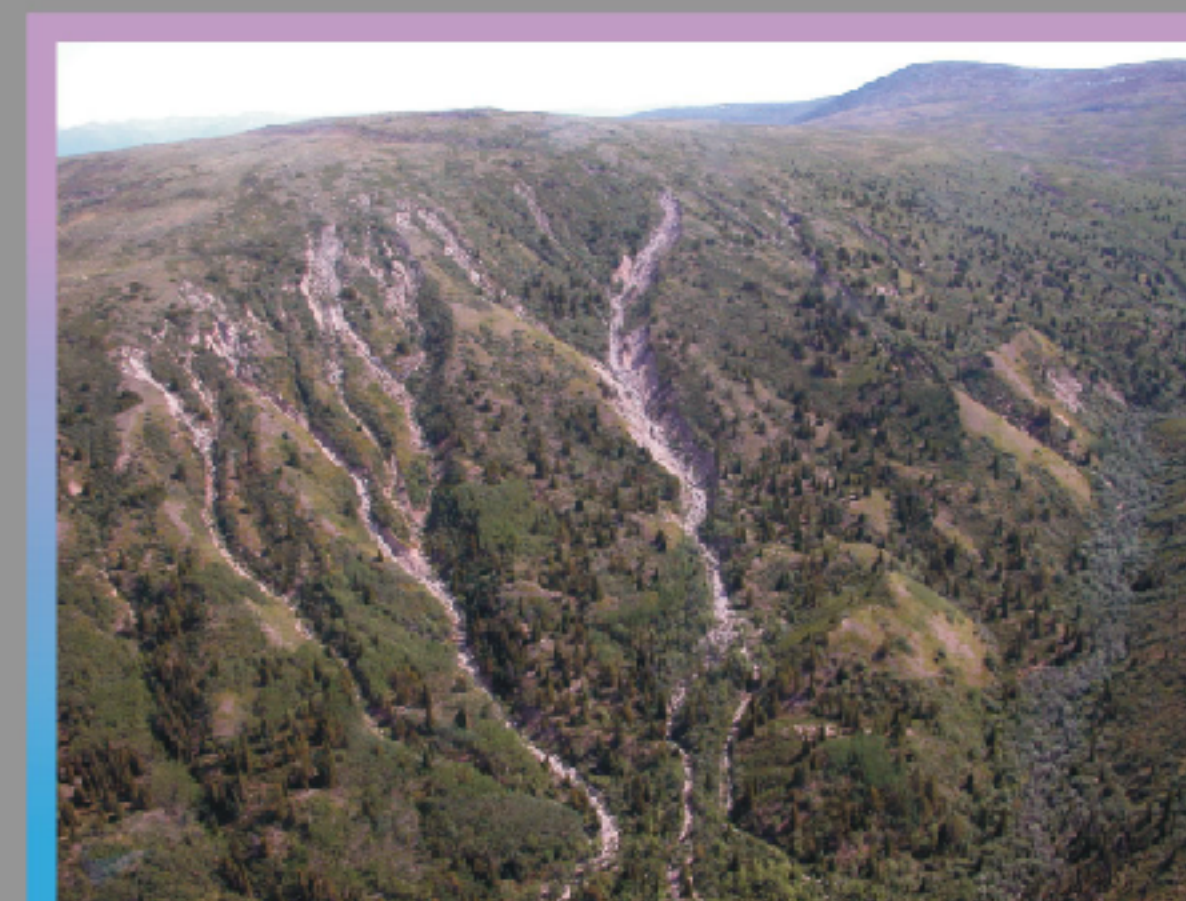
8 Mount Sumanik
Oblique aerial view of flow-related debris flows on Mount Sumanik. A 60 cm saturated soil plastic layer was discovered on top of the frozen soil above the initiation zone of the flows.

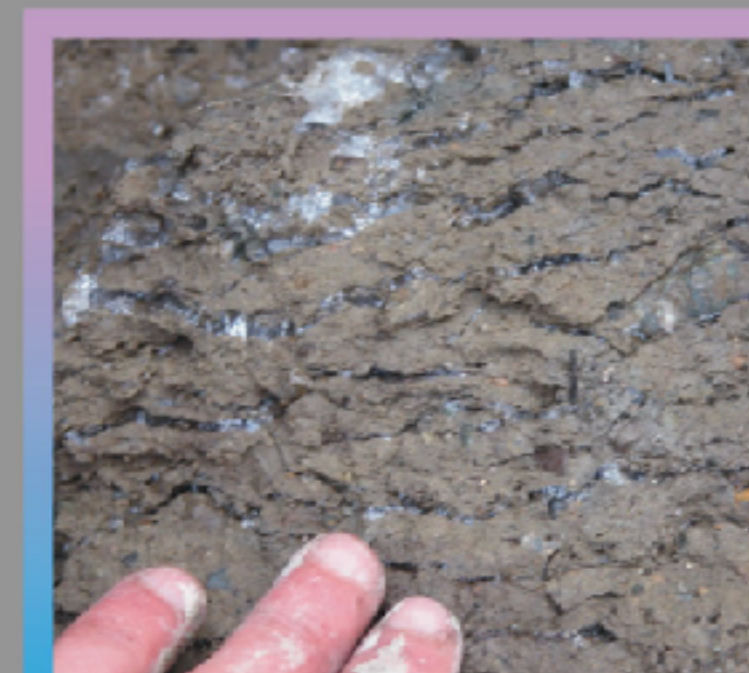
9 Haekel Hill
Permafrost encountered in soil on northern Haekel Hill, where numerous landslides occurred after a forest fire in 1991. Rapid melting of this structure causes loss of soil strength and promotes failures.
